SUBJECT: LA 6-200-C Model

DATE: December 30, 1935

TO ALL OFFICES:

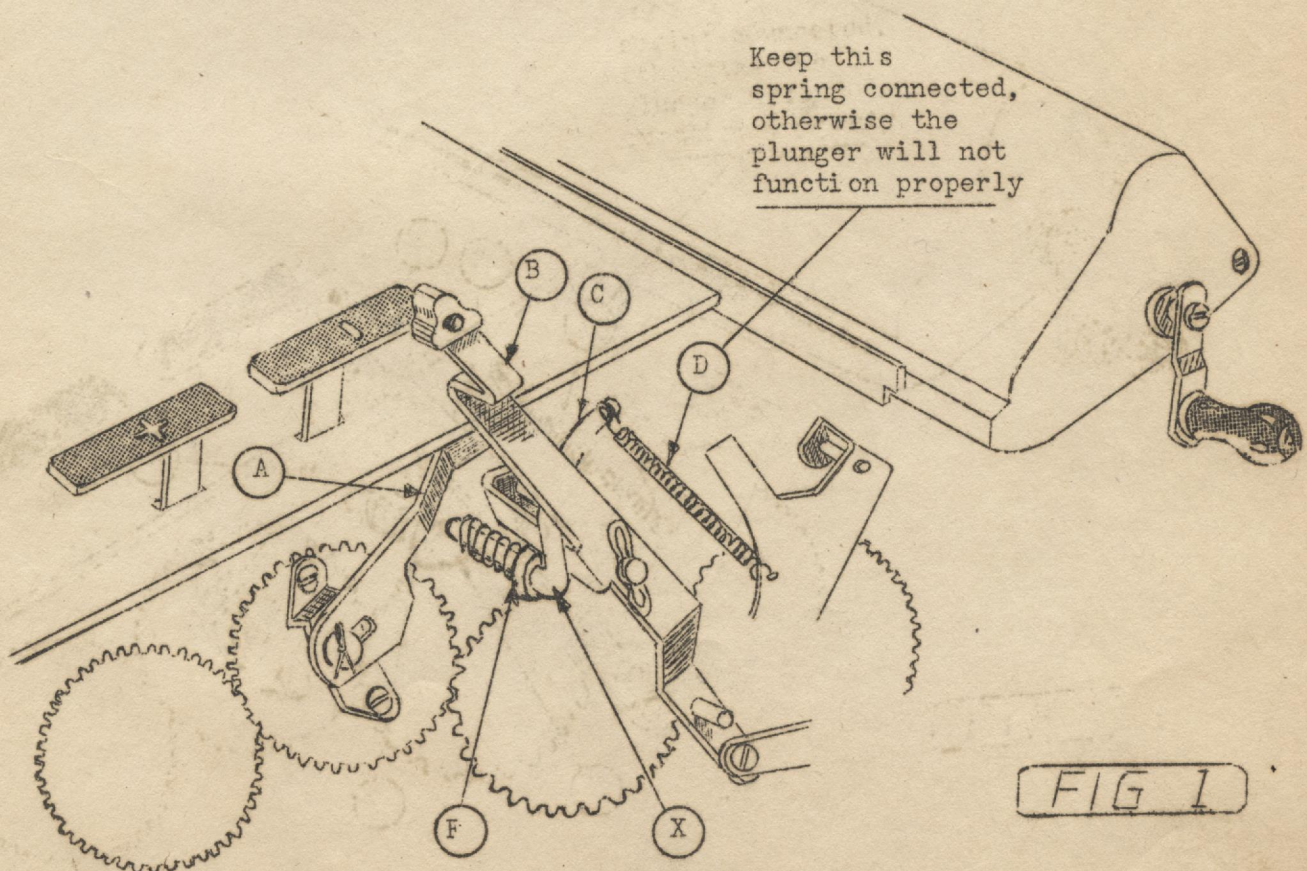
In addition to changes covered in Machine Service Bulletin No. 238, a change has also been made in the LA 6-200-C model whereby the machines will be equipped with a through-carry unit which does not contain trip levers 4310, trip lever shaft 4303 $\frac{1}{2}$ , overcarry trip lever 41-340 $\frac{1}{2}$ , screws 3007 or bearing 4309. Also a new trip lever 41-777x1 is used which is automatically disconnected during automatic multiplication by the use of a plunger rod. Long pins have been added to the 12th to 19th, inclusive, constant registering dial gears and a longer pin added to the last registering dial gear to compensate for the removal of the unit trip levers. A 47900 plunger engages the multiplication lever and extends through the side frames and the keyboard.

The left end of the plunger locates in a hole in a new style flexible end 41-779 which replaces the former 40-779, and also moves into engagement with the new 41-777x1 trip lever which replaces the 41-777. When the multiplication lever is returned to neutral, the trip lever is automatically coupled to the flexible end and serves as a regular trip lever when using the plus or minus bars or automatic division.

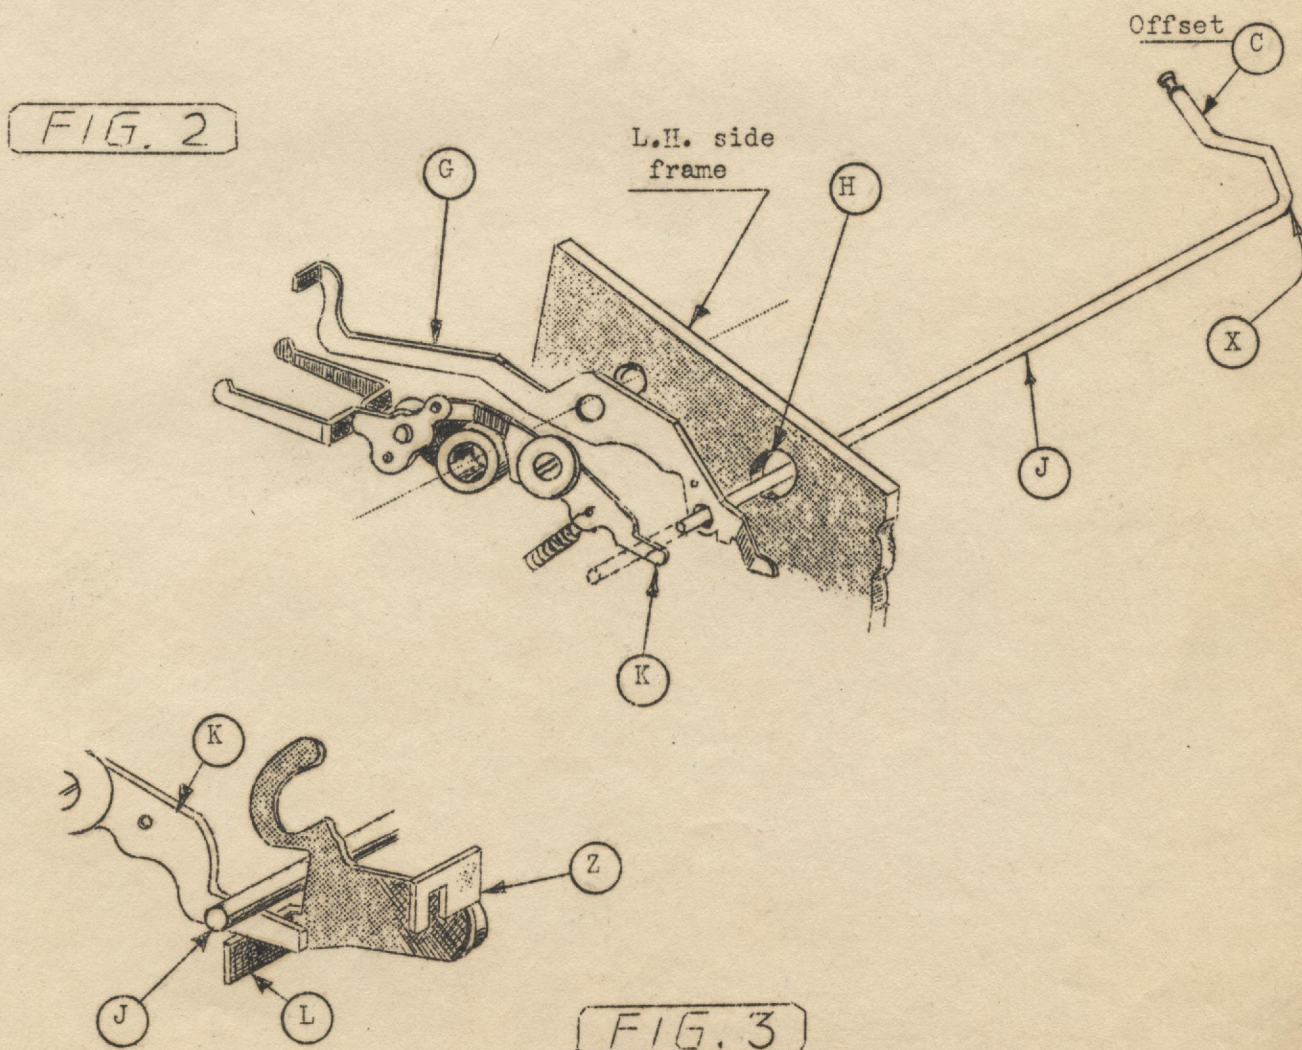
- 1 Stock has been removed from the 49070 counting finger (A) to avoid interference with the movement of the 47900 plunger rod. Figure 1.
- 2 If, after the trip lever (K) and the 41-776 guide bracket (Z) have been adjusted the plunger rod (J) should strike the inner side of the 41-777xl trip lever (K) instead of positioning over it as shown in Figure 3, remove stock from the top of lug (L) to suit.

- 3 If the plunger rod (J) does not withdraw from engagement with the trip lever (K) when the multiplication lever is positioned toward the rear of the machine, bend the offset (C) of the plunger rod inward at (X).

- 4 If the plunger rod (J) does not engage the trip lever (K) when the multiplication lever is in neutral, bend the offset (C) of the plunger (J) outward at (X).

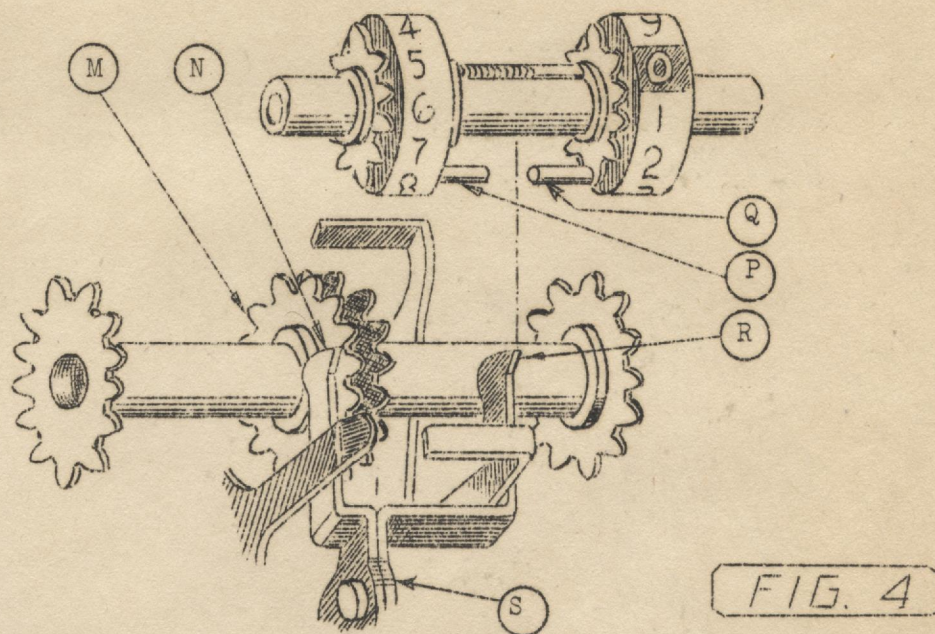
6. The outer prong (N) of the trip lever (S) should be adjusted as close as possible to the extra carry gear (M) without causing it to bind.
7. Care should be taken that the clearing pins (P) and the 41-527 carrying pins (Q) do not interfere with lug (R).
